Effects of Environment on Creep Behavior of Two Oxide-Oxide Ceramic Matrix Composites at 1200°C

THESIS

AFIT/GAE/ENY/06-S05 GAE 06S

AIR FORCE INSTITUTE OF TECHNOLOGY

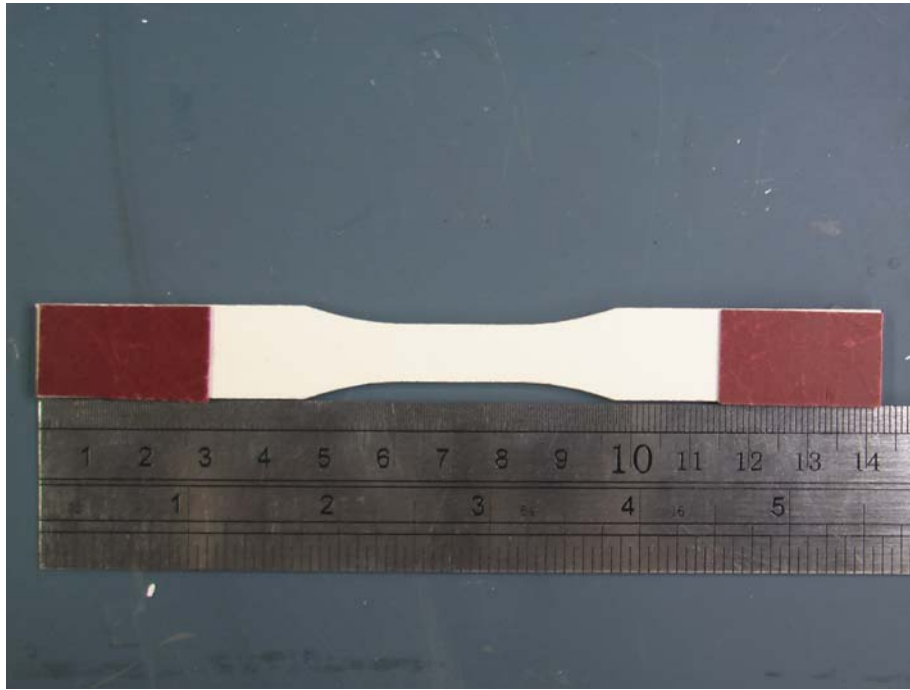
Figure 8 depicts an actual specimen.

Figure 8. Dog- bone specimen with tabs

In order to prevent damage and slippage from the hydraulic grips, fiberglass tabs were bonded at both sides on every specimen at the grip section, using M-Bond 200 adhesive.

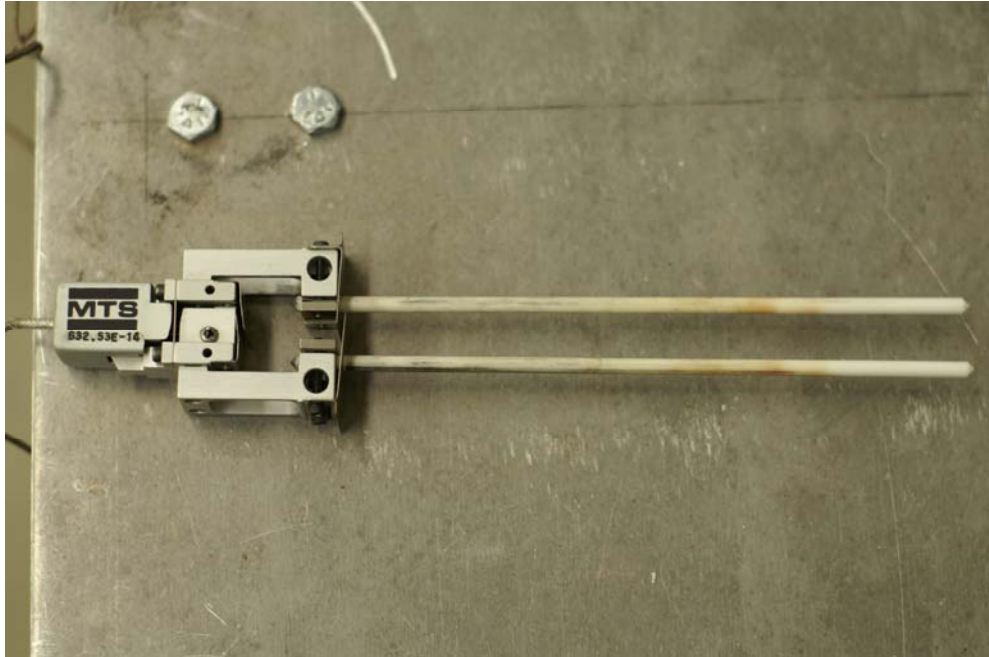
For the measurement of strain a MTS uni-axial high-temperature extensometer (model 632.53E-14) as seen in figure 10 was used. The extensometer features two 6-inch alumina rods that are used for contacting the specimen with and at their end a spring was used for keeping them in contact with the specimen.

Figure 10. MTS uni-axial high-temperature extensometer

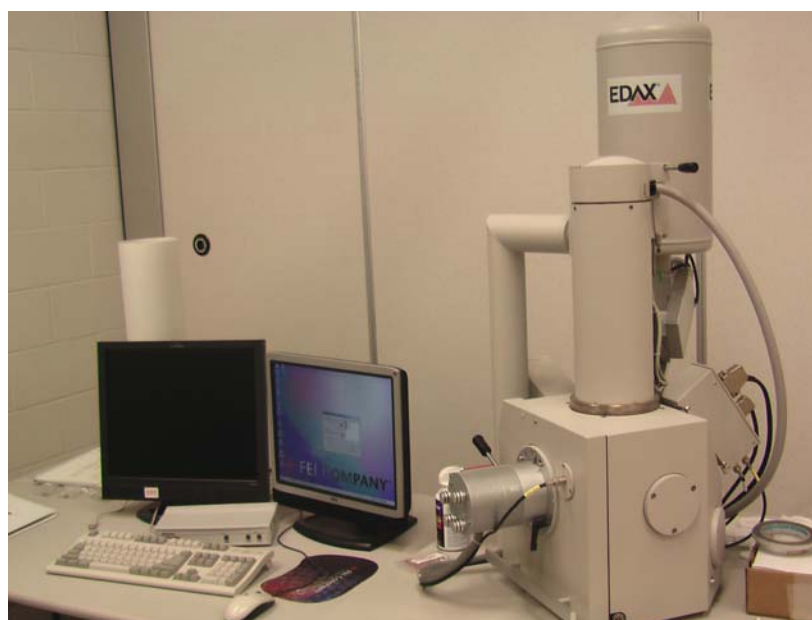
For higher magnification images a FEI FP 2011/11 Quanta 200 HV Scanning Electron Microscope which is shown in figure 16 was used.

Figure 16. FEI FP 2011/11 Quanta 200 HV Scanning Electron Microscope

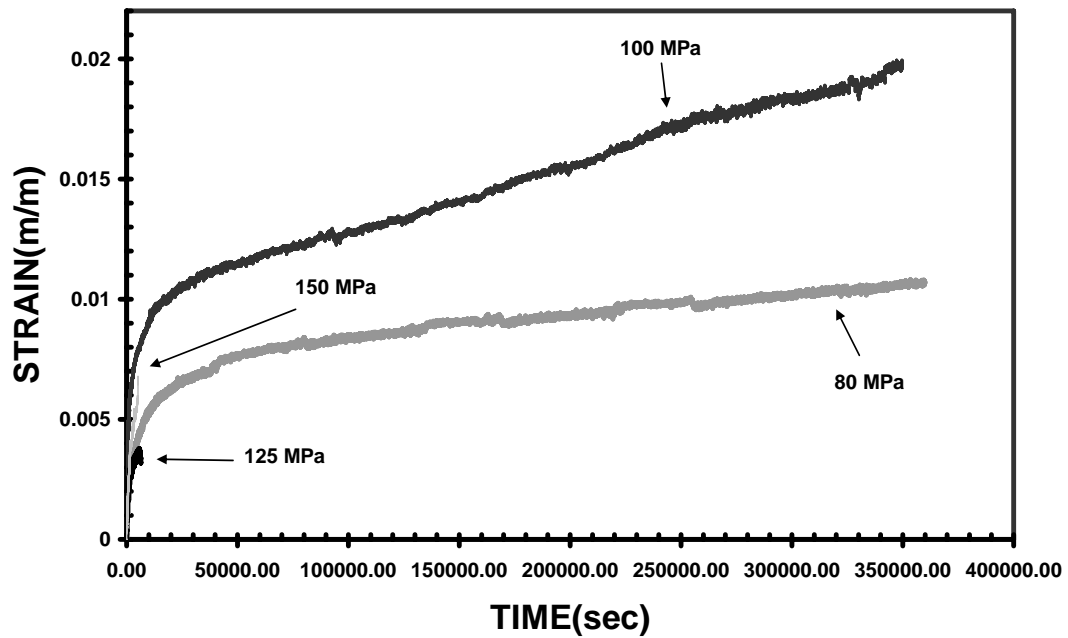
A summary of the results for Nextel 720AS specimens in argon are depicted at table 4. Specimens at stress levels of 100MPa and 80MPa withstand their loads for 100h, whereas the specimens loaded at 150 and 125 Mpa had a time to failure of 1.5 and 1.76. All specimens had both primary and secondary creep regions while the specimen loaded at 150 MPa had also a tertiary region. The maximum strain was obtained from the loading at 100MPa.

Figure 24. Creep Strain vs Time for N720/AS in argon 1200°C

Figure 25. Creep Strain vs Time for N720/AS in argon 1200°C (Time Truncated)

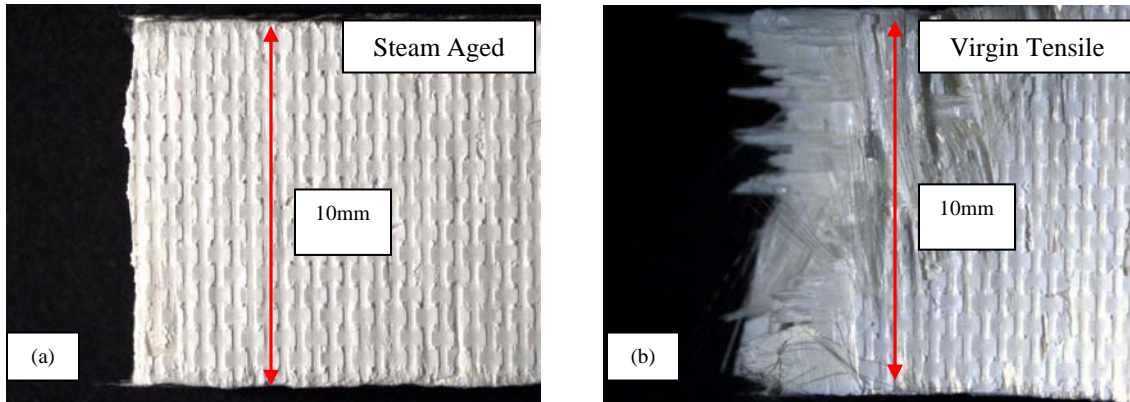
Figure 45 illustrates the fracture surfaces of the N720AS CMC after tensile test for a specimen aged in 100% steam environment for 12 hours in 1200°C (a) and for a specimen tested in tensile after heating up up to 1200°C in air (b). It can be seen that the fracture surface of (a) follow the pattern of the surfaces of specimens tested for creep in steam as depicted in figure 41. Specimen (b) has brush fracture surface much like the specimens tested in air or argon for creep at high load levels.

Figure 45. N720AS specimens fractured in tensile test in 100 % steam environment (a) and in air environment (b) at 1200°C

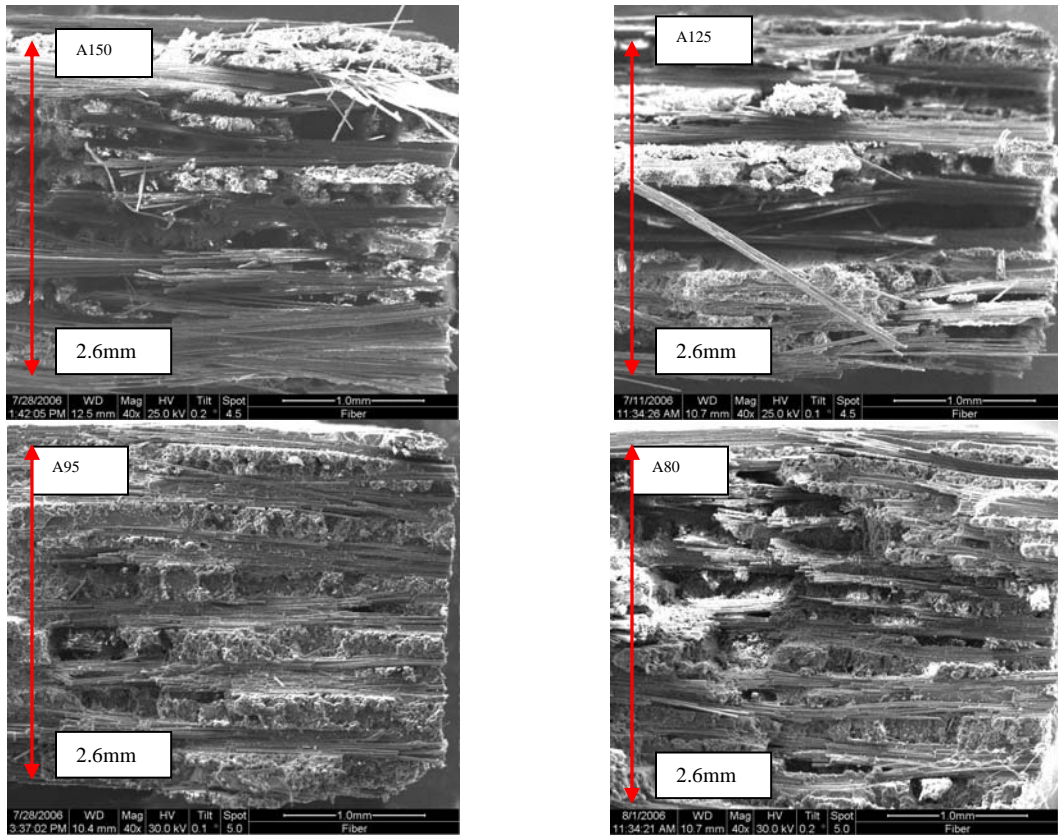
Following the optical microscopy observations, the specimens were prepared and observed at the Scanning Electronic Microscope. Figures 46, 47, 48 and 49 illustrate the fracture surfaces of the specimens at 40x magnification. This magnification was chosen as the whole width of the specimen can be observed. From the analysis of the fracture surfaces the trend that was discussed earlier for N720AS CMC seems even more obvious. The lower the load level of the specimen, the more flat its fracture surface is. And again the specimens tested in steam are more flat than the specimens tested in air or argon at the same load level.

Figure 46. N720/AS Specimens at Air – 40x Magnification

Figure 47. N720/AS Specimens at Steam – 40x Magnification

Figure 48. N720/AS Specimens at Argon – 40x Magnification

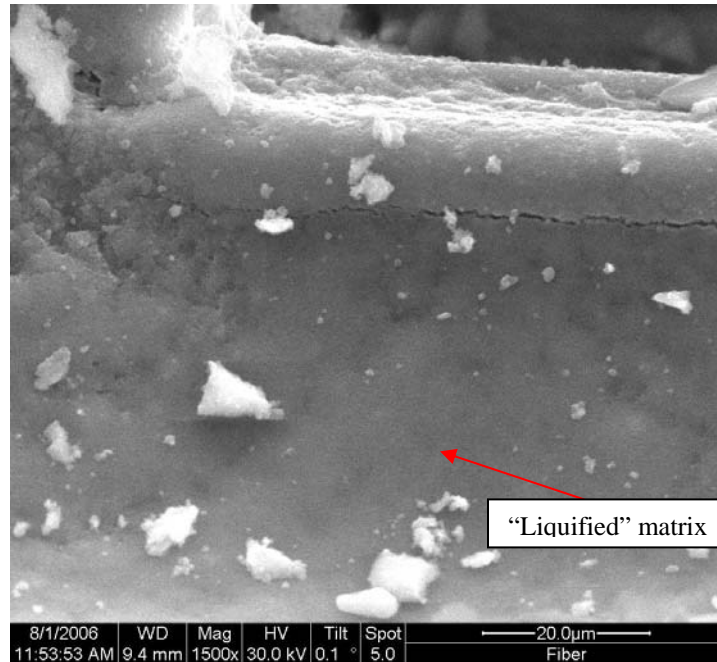
Further examination of the specimens at the SEM, revealed spots at the fractured surfaces where matrix material seemed as it was “melted” or “liquified” during the test. This pattern can be seen at figures 54, 55, 56, 57. It should be noted that this ‘melted’ phase of the matrix material was observed only in specimens that were tested in lower load levels- that is the specimens that stayed longer at 1200⁰C. The fact that this phase is present at specimen S100 that fractured after only .27h signifies that the steam environment “accelerated” this transformation of the matrix.

Figure 54. Specimen S100- 800x

Figure 56. Specimen A80- 800x

Figure 57. Specimen A80- 1500x
